PROPERTY RE-INSPECTION REPORT

Concerning: Your New House

BARRY ADAIR TREC #4563

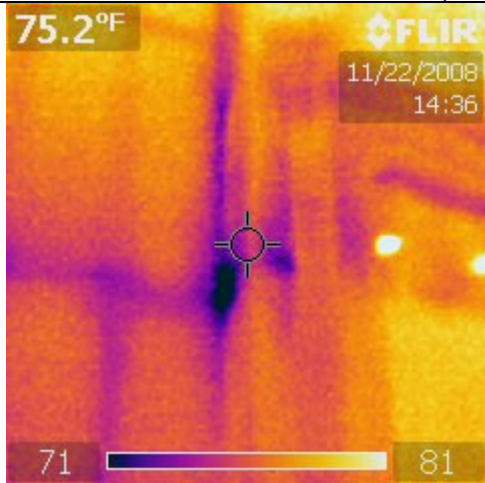
Air infiltration or absent insulation both sides of the great room fireplace

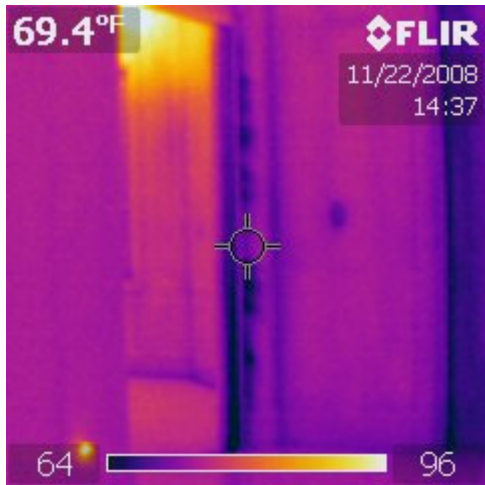
Air infiltration at the office pocket doors

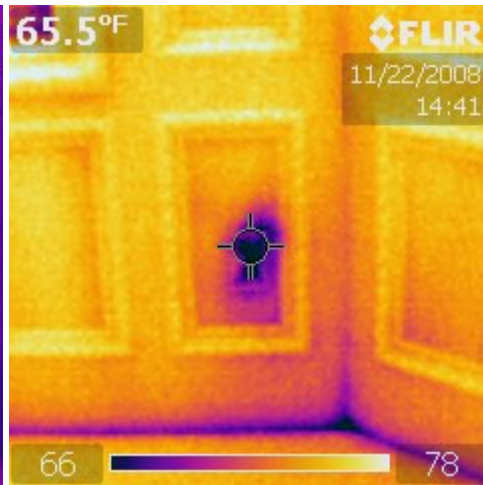
Typical at all locations air infiltration at receptacles
Install insulating gaskets at all locations

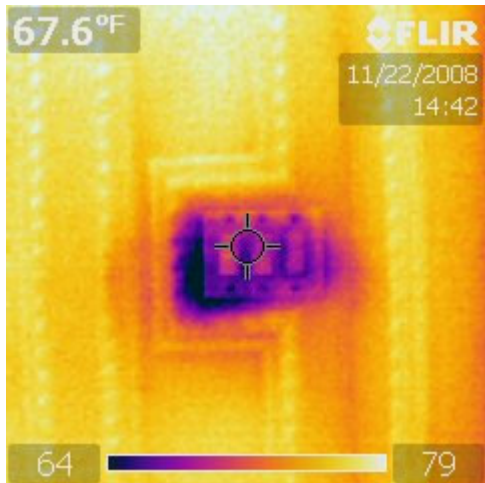
Typical at all locations air infiltration at switches. Install insulating gaskets at all locations

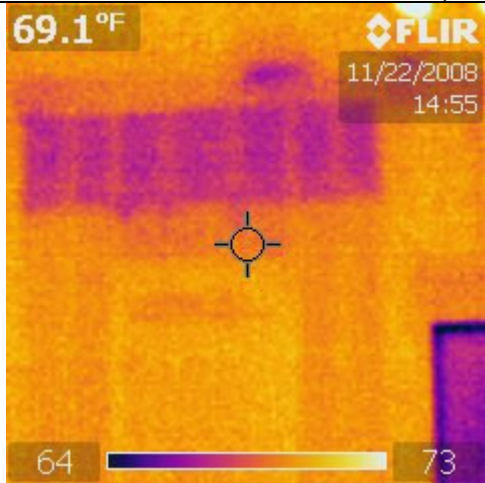
Insulation voids at guest room over exterior door

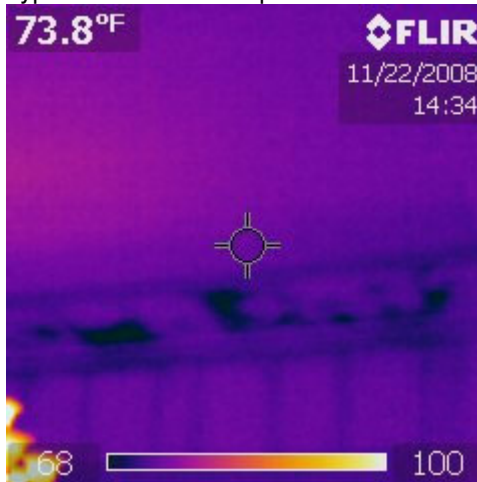
Den back

Typical Infrared examples of air infiltration, absence of or displaced insulation (dark areas in images)

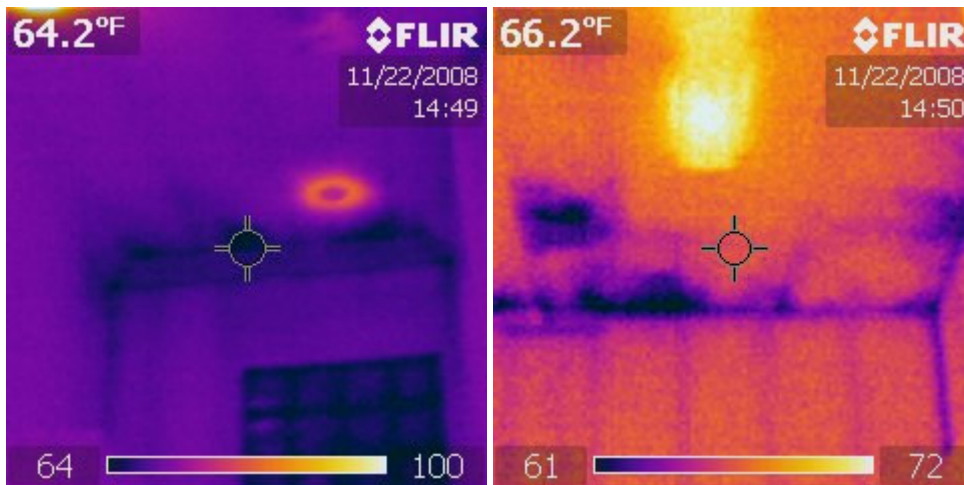
Master bath front

Master closet air infiltration or absent insulation

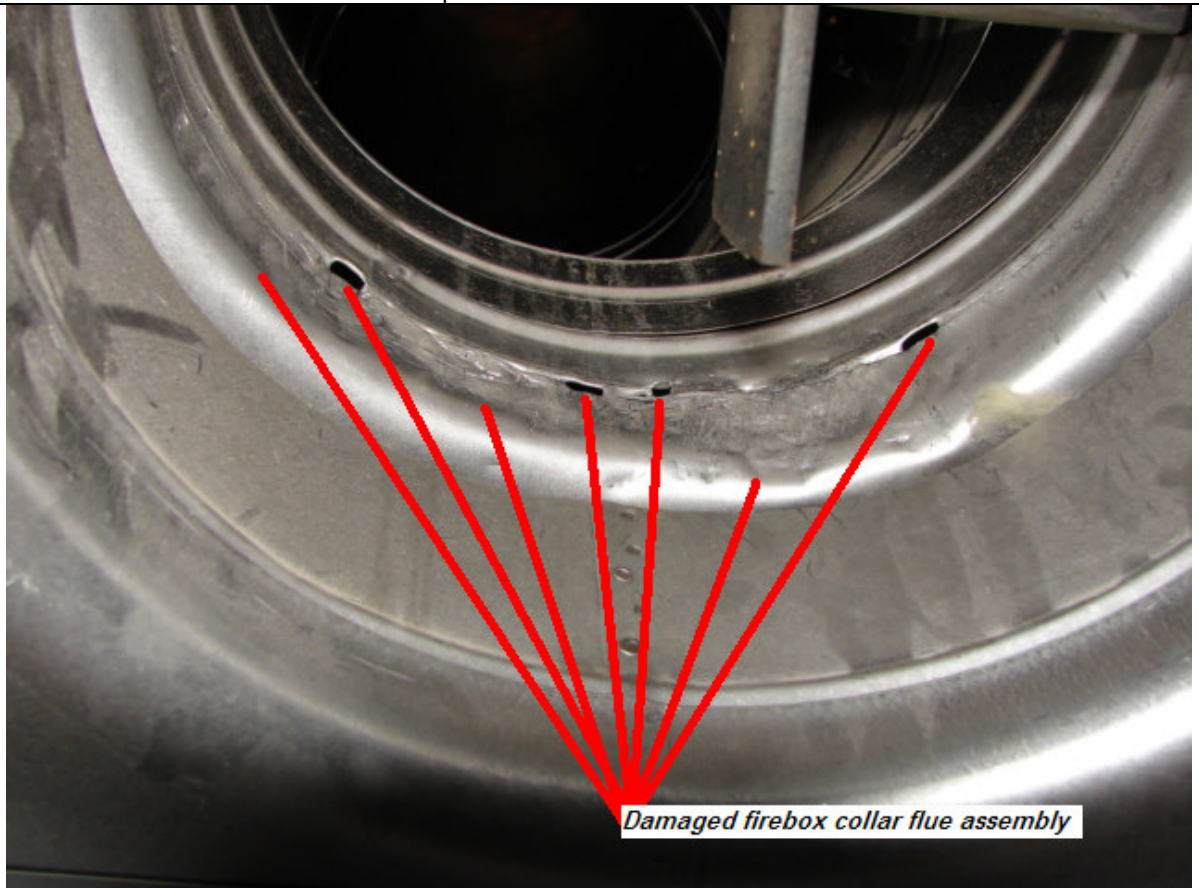
- 80, 81- Clear all construction debris and insulation out and away from the chimney flues
[Appears repaired from previous inspection](#)
Consult a licensed and or certified tradesperson for evaluation of the entire system's components when defects or repairs are noted.
- Potential air or water intrusion detected with IR, inside the home, at the top and fire-blocking areas of the (great room) fireplace also at the level of the top of the mirror.
- Exterior of home shows possible missing flashing at the base of the chimney chase to roof intersection. See wall or roof comments
