2013 ADAIR INSPECTION PROPERTY INSPECTION REPORT COMPARISON

Concerning: **The House**

**BARRY ADAIR TREC #4563**

PROPERTY INSPECTION REPORT

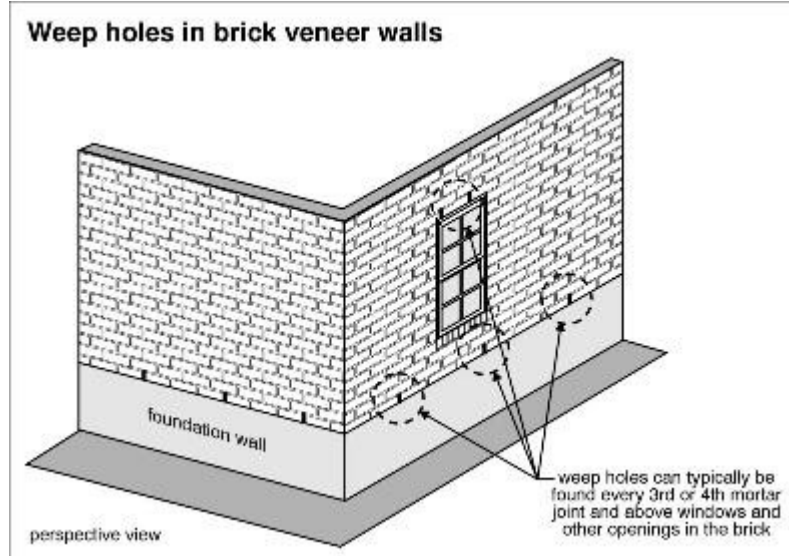
- 2, 3, 19- There are hairline cracks at numerous horizontal and vertical masonry veneer locations monitor for further movement and repair as needed
- 2, 3, 7- The required lintel and or window and door flashing is not visible and weep holes are not properly installed or cleaned of mortar debris.

2, 3, 19- The presence of corrosion at any metal lintel surfaces is not only an aesthetic detractor but will eventually compromise its proper function and structural integrity. Therefore, periodic cleaning and clearing of all surface corrosion and repainting is required and advised too avoid failure before it occurs. Unsupported masonry failure from elevations is a known safety hazard. For severe climates and exposures consideration should be given to the use of galvanized or stainless steel lintels or shelf angles. At a minimum any steel angles should be shop primed with a corrosion inhibitor coating and repainted if the steel will be welded or whenever corrosion is evident. Even where these materials are used continuous flashing should be installed to cover and lip over the angle too ensure corrosion protection.  
<http://www.masonrysystems.org/pdf/Literature-Review-Corrosion-Protection.pdf>

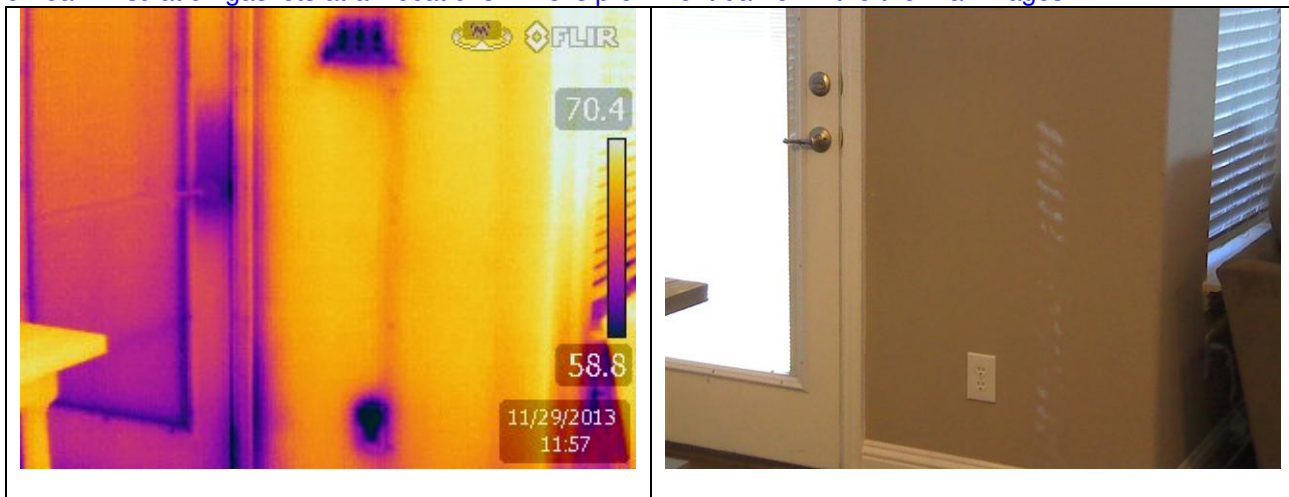
56- Numerous interior and exterior wall receptacles and switches have air leakage present advise installation of foam insulation gaskets at all locations. This is prominent darker in the thermal images.

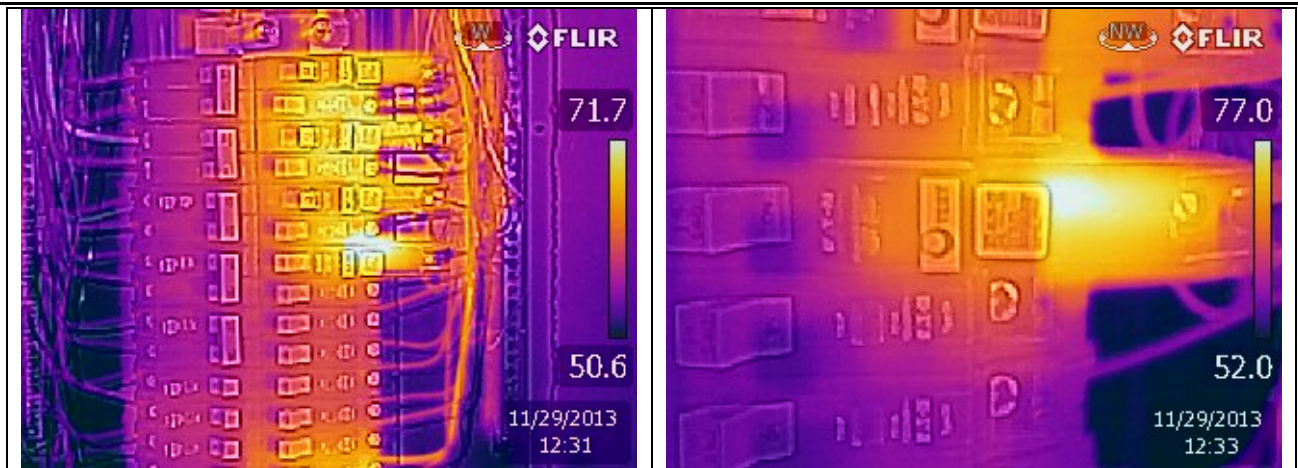
66- The bottom AFCI did not trip by the internal test button. Advise **Immediate replacement** with a properly working device. Also excess heat was noted with thermal imaging see overview and detail images below.

During the testing of the existing Arc Fault Circuit Interrupter (AFCI) breakers one failed to de-energize when its test button was pushed. The following areas of the home did not de-energize while all others required did. The entire second floor, front, left bedroom, bathroom, and closet. The first floor, front bedroom's bathroom and closet.

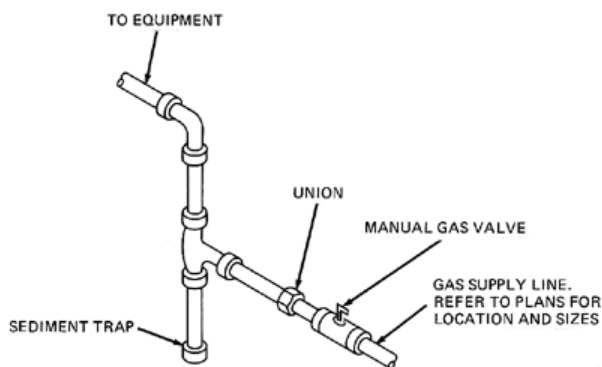
42, 45- Install a sediment trap as required at the cooktop gas supply. Where a sediment trap is not incorporated as part of the gas utilization equipment, a sediment trap shall be installed downstream of the equipment shutoff valve as close to the inlet of the equipment as practical. The sediment trap shall be either a tee fitting with a capped nipple in the bottom opening of the run of the tee or other device approved as an effective sediment trap. Illuminating appliances, ranges, clothes dryers and outdoor grills need not be so equipped.
