2013 ADAIR INSPECTION PROPERTY INSPECTION REPORT COMPARISON

Concerning: **The House**

**BARRY ADAIR TREC #4563**

PROPERTY INSPECTION REPORT

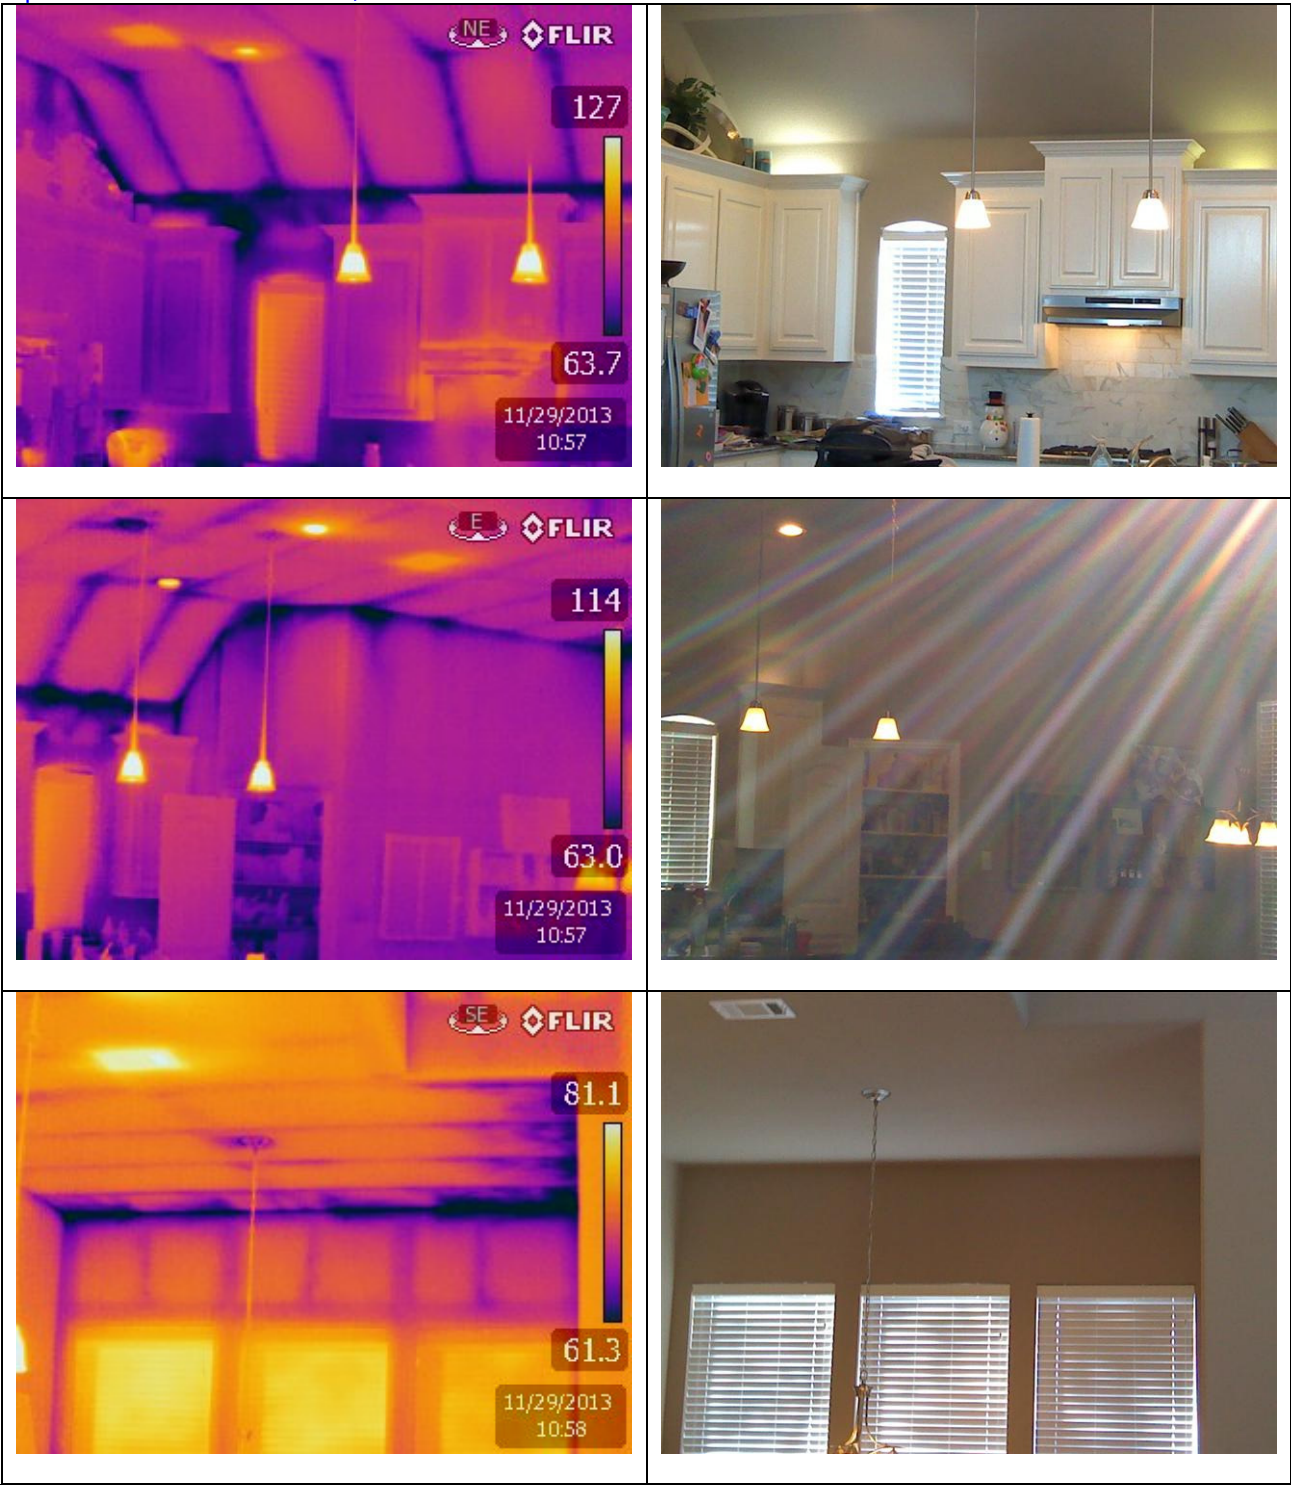
insulation removed from the ceiling void where stairs have been installed.

Typical: Below you will see numerous areas that may possibly have displaced or absent insulation. If any of these areas are not readily accessible from the attic spaces invasive examination will have to occur too make a definitive assessment and any further insulation re/placement recommendations. Many of the finite darker or lighter vertical, horizontal and diagonal lines are thermal bridging of the framing members and are not repairable items. Overall cost; return vs. reward should be considered.
